RE: Sealant Compatibility Test with Sentryglas® Interlayer

Two separate lots of both S450C and S150C were tested in accordance with standard ETAG 002, 5.1.4.2.5 Method B - Effects of Materials in Contact with UV, Peel Test with Incisions – using Sentryglas® samples.

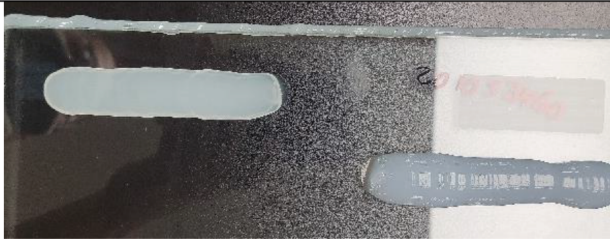
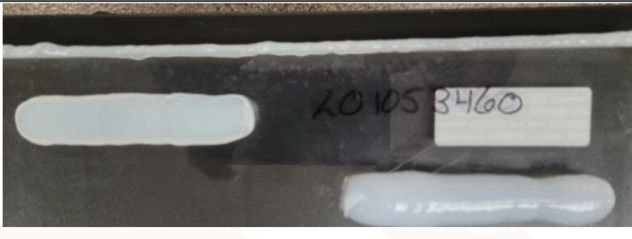
Prior to UV Exposure	After 504 Hours UV Exposure
S450C 201053460

After the sealant was applied to the panels, they were allowed to cure for 72 hours at 72°F at 50% RH. The panels were then placed into a Xenon QSUN with the Laminate Label side facing away from the light source and subjected to ASTM G155 for 504 hours. After 504 hours, the beads were manually peeled back, and the area was observed for failure mode and staining/discoloration. Below are the results:

PHOTOS OF FACE/BACK

Material	Position on Sentryglas	Failure Mode	Staining/Discoloration
S450C 201053460	FACE	100% Cohesive	Slight Yellow Hue*
S450C 201053460	BACK	100% Cohesive	Slight Yellow Hue*
S450C 201053460	Interlayer	50% Cohesive / 50% Adhesive	None
S450C 210857230	FACE	100% Cohesive	Slight Yellow Hue*
S450C 210857230	BACK	100% Cohesive	Slight Yellow Hue*
S450C 210857230	Interlayer	100% Cohesive	None
S150C 191234425	FACE	100% Adhesive	Slight Yellow Hue*
S150C 191234425	BACK	100% Adhesive	Slight Yellow Hue*
S150C 191234425	Interlayer	100% Adhesive	None
S150C 210917621	FACE	100% Cohesive	Slight Yellow Hue*
S150C 210917621	BACK	95% Adhesive / 5% Cohesive	Slight Yellow Hue*
S150C 210917621	Interlayer	50% Cohesive / 50% Adhesive	None

*The slight yellow hue is noticed only on thick sections of the sealant beads and is dependent on the observation angle.

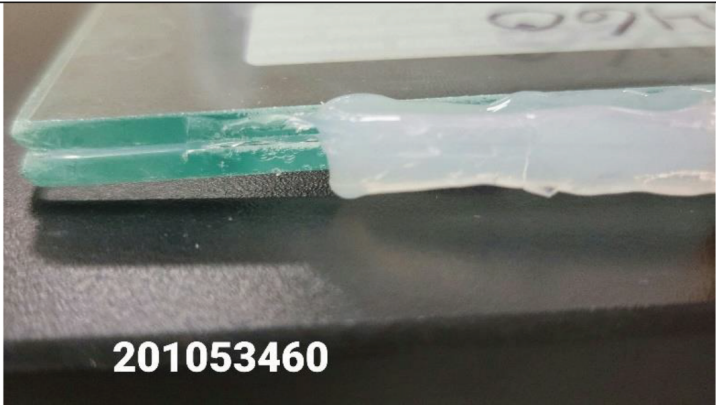
S450C 201053460

PHOTOS OF INTERLAYER AFTER 504 HOURS
